INSPECTION CONDITIONS

REPORT NAME 1994.
FILE #: 0001994.
DATE OF INSPECTION: 12/03/2005.
TIME OF INSPECTION: 8:45 AM -- 3 PM.
CLIENT NAME: Thomas & Khara Flint.
MAILING ADDRESS: 15 E. Butler Ave.
CITY/STATE/ZIP: New Britain PA 18901.
CLIENT HOME PHONE
INSPECTION LOCATION: 25 Scott Dr.
SITE CITY/STATE/ZIP: Churchville PA 18966.

INSPECTED : Old stone farm house with several additions. Detached carriage house with apartment and lower storage. NOT INSPECTED: Several other detached shed / barn type buildings.

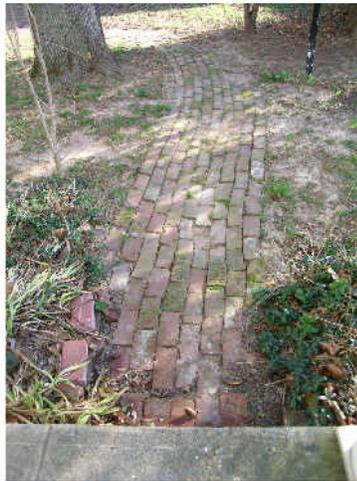
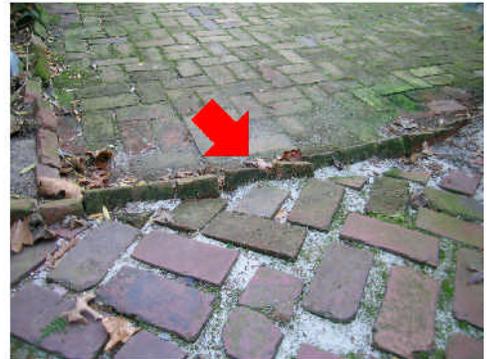
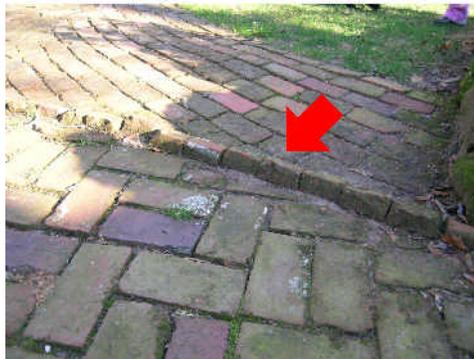
Walkway / patio severe trippers.

There are several possible trippers in the walkways and the patios that the buyer needs to be aware of. Any abrupt difference in the level of a walkway,

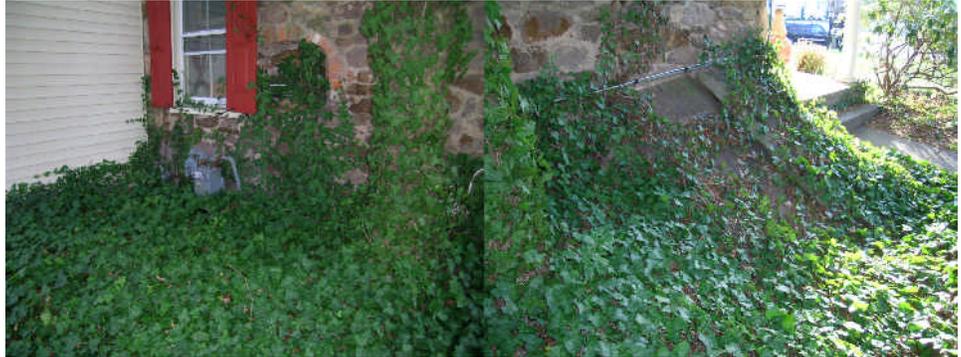
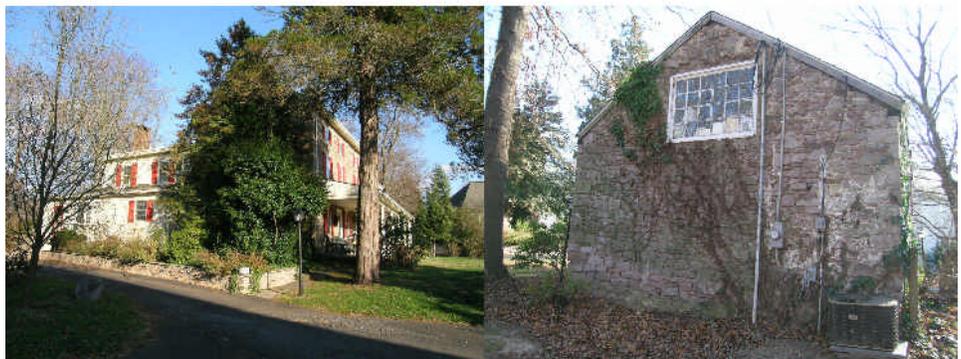
Vegetation limits / prevents view / inspec

It is important to keep bushes ,shrubs , and trees back away from the from the house. There should be 10 inches to 1 foot between the bush and the house so that good air flow / ventilation can carry away moisture that can be trapped close the house by the vegetation. It is also very important to be able to view the exterior of the foundation wall. Many times being able to view the exterior of the foundation of the house is the best way to prevent infestation by wood destroying insects. Maintenance needed. Vegetation needs to be trimmed back away from the house. Vines growing on the exterior of the house need to be removed. Over time they may cause damage that will need repair. Trees planted close to structure. Removal may be necessary. Vegetation and vines prevent view / inspection of several areas. Particularly the lower siding and exterior foundation. Trim / remove so exterior wall covering and exterior foundation is clearly visible. Photos in main report.

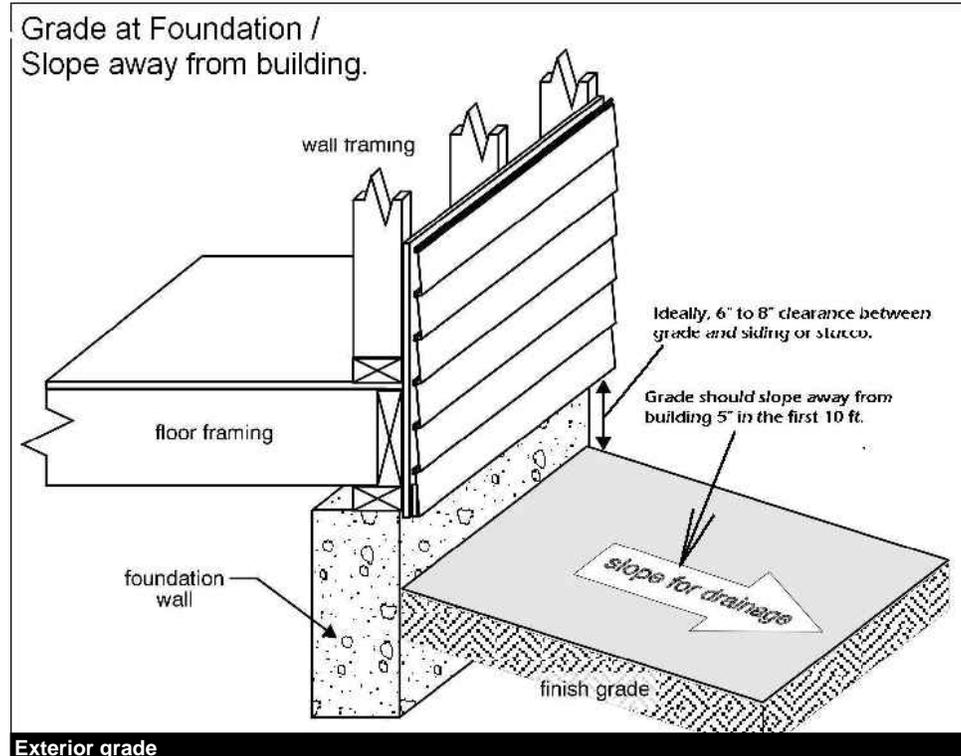
Exterior grade

The grade / slope around and away from the house can be a major factor in keeping water out of the basement. The grade should slope / fall away from the foundation at a minimum of 1/2 inch per foot and extend at least 10 feet away from the foundation. Ideally, you should be able to see 6 to 8 inches of your exterior foundation wall. Many times, because of grade restraints this is not possible. But you should never have the soil / grade up to, or over the siding at any time.

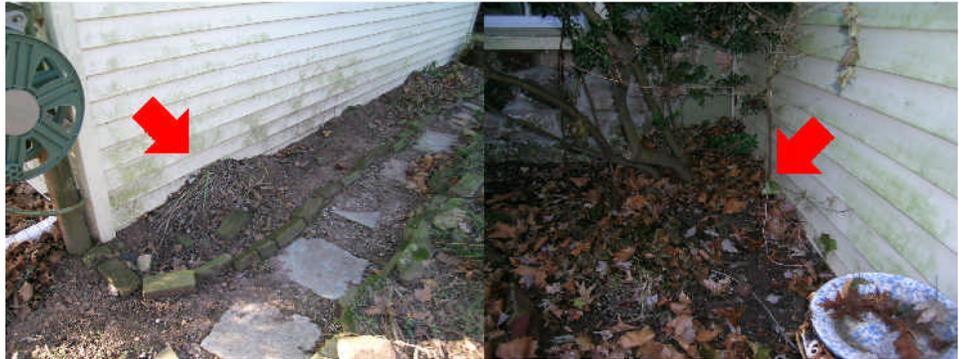
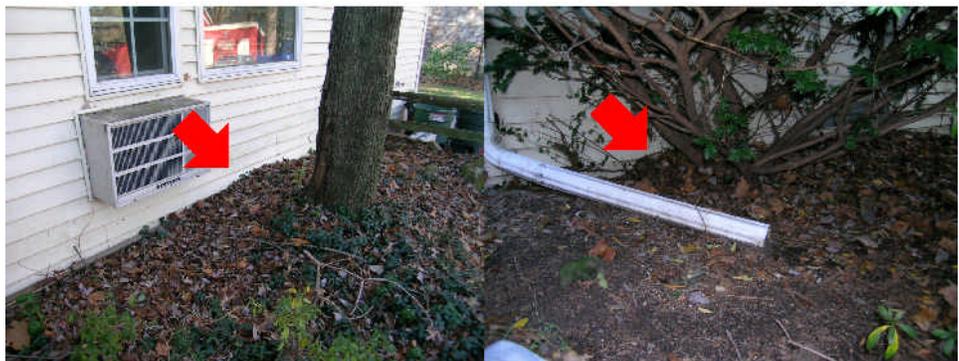
Soil Siding contact several locations

Part or all of the grade around this house would be considered a flat site. Surface water may not drain away as quickly as it should. Water that does not drain away quickly may enter the basement and cause a number of possible problems. Water may not drain away as fast as it should. If water does not drain away from the house there is a higher probability that it will enter the basement.

I found soil and / or mulch in direct contact with the house siding at several locations. Photo in main report. The soil or mulch should never be in contact / touching the house siding, trim, or wood. Ideally, you should be able to see 6 to 8 inches of your exterior foundation wall. Many times, because of grade restraints this is not possible. But you should never have the soil / grade up to, or over the siding at any time. This condition promotes deterioration from moisture as it transfers to the wood, but even more of a concern is the increased likelihood for insect (including termite) infestation. Many times having this exterior foundation exposure is the best way to prevent insect infestation into the house. Most houses are just not quite high enough out of the ground. Grade at foundation needs correction, Lower soil / mulch so that it is below the siding / wood. Grade should be 6 to 8 inches below any wood or siding materials and it should slope away from the house so water drains away quickly.

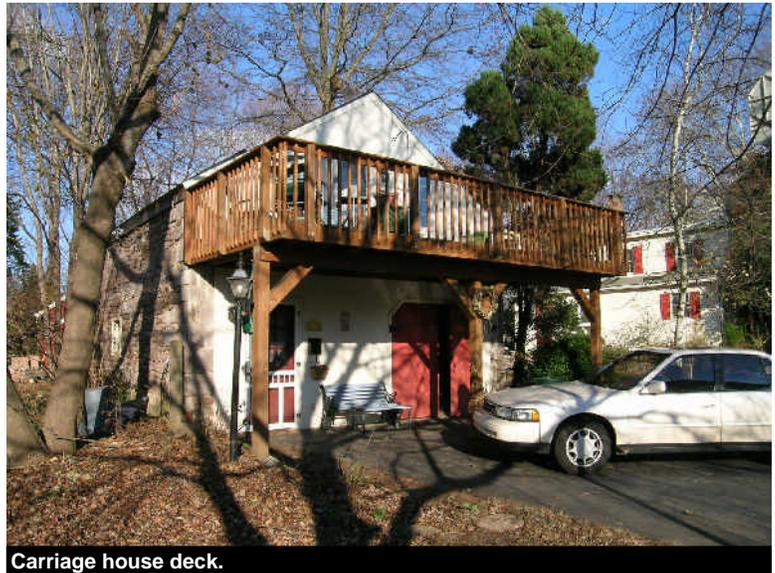
Carriage house deck.

The exterior deck / carriage house balcony appears to be in satisfactory condition.

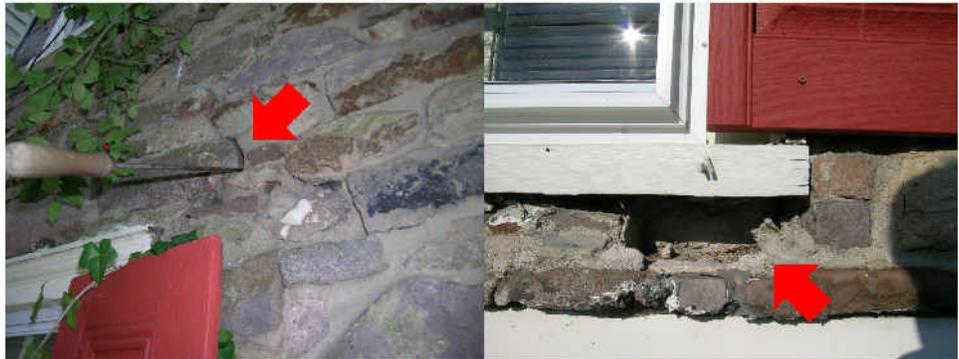
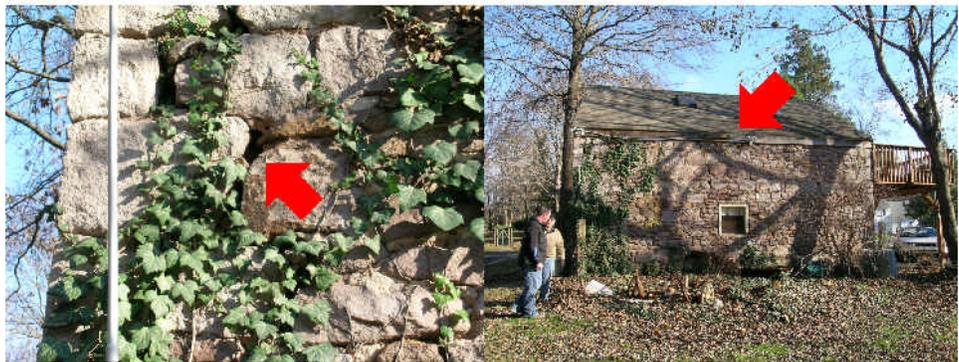
Stone walls need repair and re-pointing

Most of the house and the carriage house have stone or stucco on stone exterior walls. Solid stone was common only in older houses. Most houses built today have stone veneer. Stone is installed on / over wood framed walls.

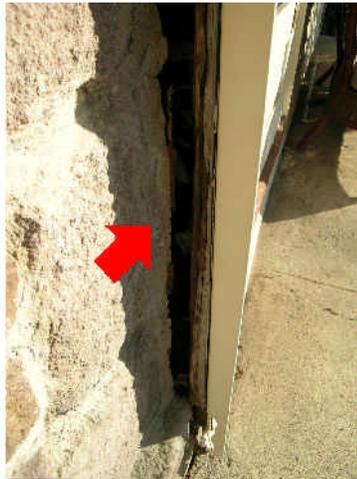
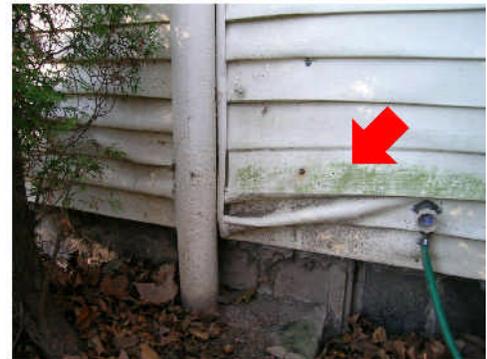
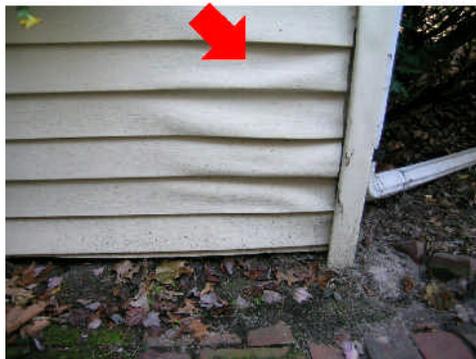
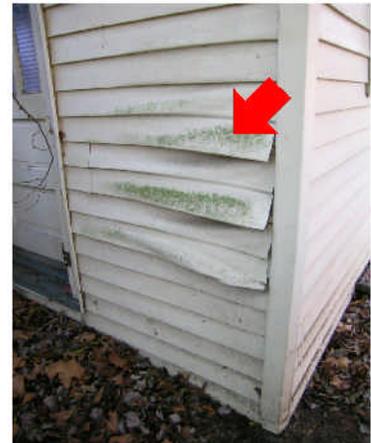
Siding repair necessary

This section is graded poor for several reasons. Ivy / vegetation cover limits view / inspection. I found loose or missing stone, and deep open joints where mortar is missing at both the house and the carriage house. Several areas of the house and the entire carriage house need missing or loose stones

installed / reinstalled and re-pointing. I also found a crack in the stone on the driveway side gable end of the main house that is larger than normal. This crack does not imply an immediate structural concern but is should be further evaluated , repaired and monitored. A qualified mason should be consulted prior to final purchase decision to determine the extent of deterioration / damage and the cost to repair.

This section is also poor because several areas of the main house vinyl siding appear to be heat damaged and / or peeling away from the wall structure. Owner provided a reasonable explanation for melted / heat damaged siding located on the lower left gable end of the main house around the sewer vent pipe, but other two areas of heat damaged siding need an explanation. All need repair. Vinyl siding directly to the left of the far right front entrance door is peeling away from the wall structure. There is some evidence of deterioration behind this vinyl siding. It's important to note that directly below this area evidence of termites was found. Buyer needs to be aware that there may be severe damage behind the siding. Further evaluation by a qualified carpenter / contractor to determine the extent of damage and the cost to repair is necessary.

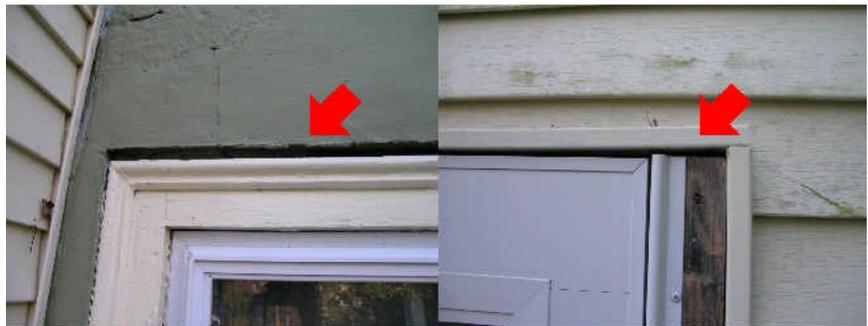
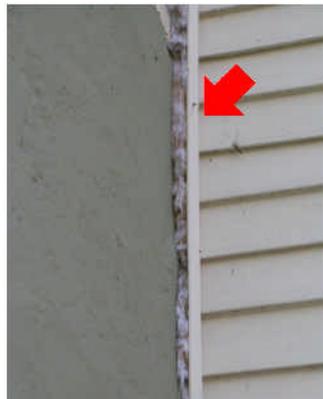
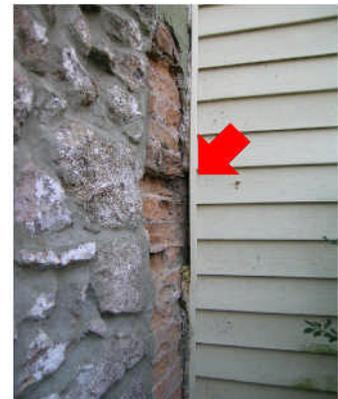
Properly fill and seal gaps / joints

The exterior trim includes but is not limited to the following. Window & door trim, corner trim, soffits, fascia / cornice / frieze trim, rake trim, dentil trim, and gingerbread. This house has both wood and metal capped exterior trim. Wood

needs to be maintained, painted, caulked, and sealed or it will deteriorate and replacement / repair will be necessary. It is important that joints in the metal capping and joints where the metal capping abuts other dissimilar materials be caulked so that water / moisture does not enter / get behind the metal. If this happens the moisture could cause deterioration that may not be seen until it is quite extensive.

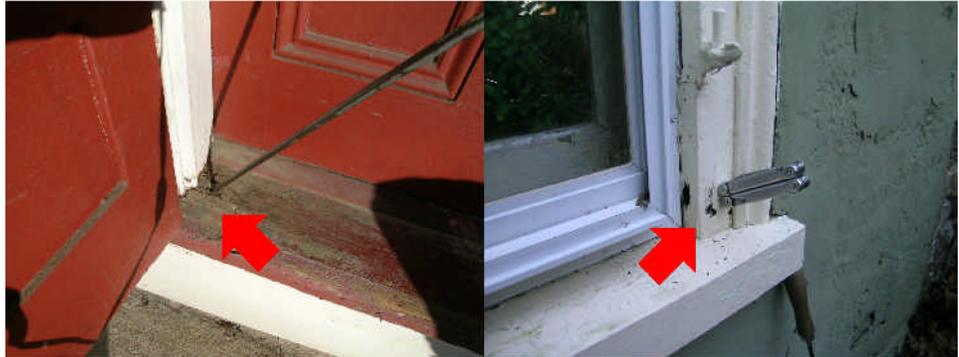
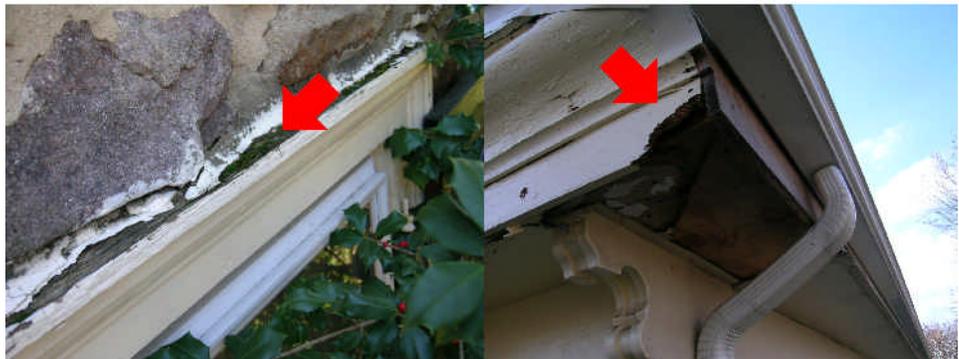
Wood deterioration needs repair.

Damage noted. I found a number of areas where wood trim is deteriorated. Wood sill and window / door trim deterioration.

Photos in main report. Before final purchase decision is made, a qualified carpenter / contractor should further evaluate along with the exterior wall covering to determine the extent of damage and the cost to repair. (Both main house and carriage house)

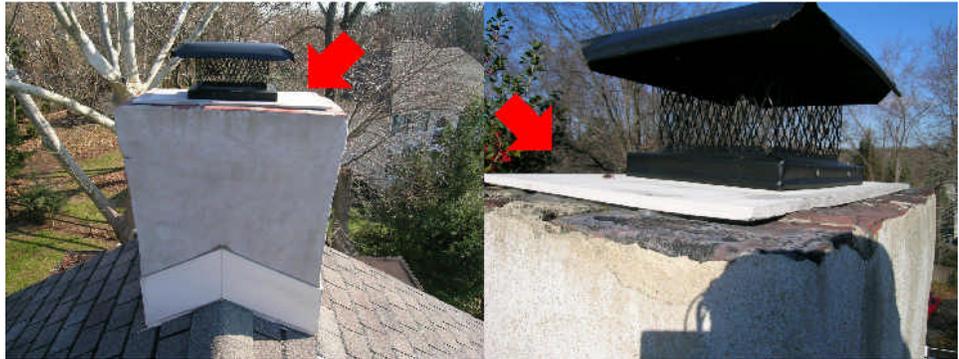
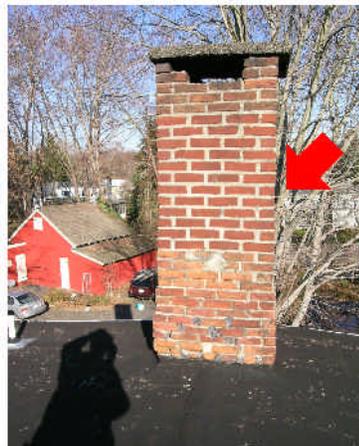
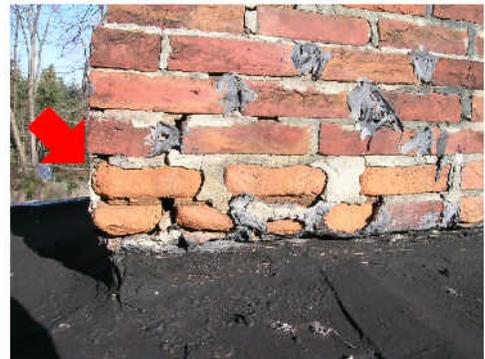
Chimney repair necessary!!!

Repairs needed. The three chimneys appear to be unlined. This house has an unlined flue.

Older chimneys were not built with interior liners that protect the masonry structure from the highly corrosive combustion gases that use the chimney to exit the house. These corrosive gases eat away the inside of the chimney. Without a liner such as terra cotta pipe the gases can cause severe damage to the flue of chimney and eventual structural deterioration. This can also be a source of entry for deadly carbon monoxide gases into the living space of the house. For this reason further evaluation is necessary to determine the exact condition of the interior of the chimney flue. If a liner is not installed at this time buyer needs to monitor this chimney and plans for a liner should be made.

Kitchen fireplace chimney has severely deteriorated brick. Repair is necessary. Photo in main report.

A qualified chimney mason / sweep should be consulted, before final decision to purchase, to determine the extent of necessary repairs and the cost to complete them.

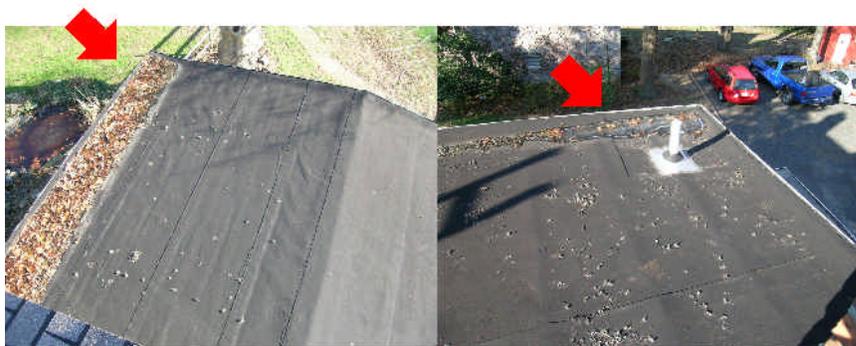
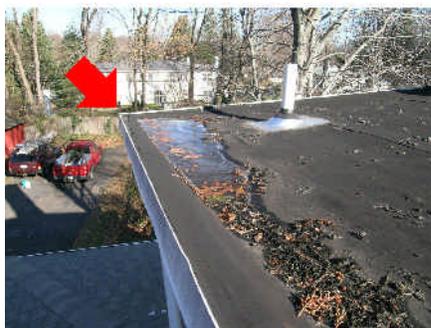
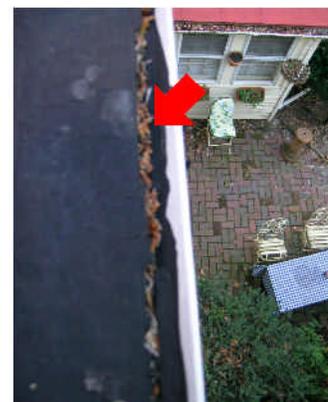
Seal membrane edges / clean debris

Roofs are in overall satisfactory condition with the following concerns. At the time of the inspection both membrane roofs on the main house have puddled water / ice in the built in gutters. This is likely from deciduous material ,leaves, twigs, etc. Puddled water / ice on flat roofs is an invitation for leaks. Clear / clean all debris from roofs and gutters or leaks will occur.

Edges where membrane roofs abut metal drip edge have some gaps that should be sealed to prevent water penetration / leakage.

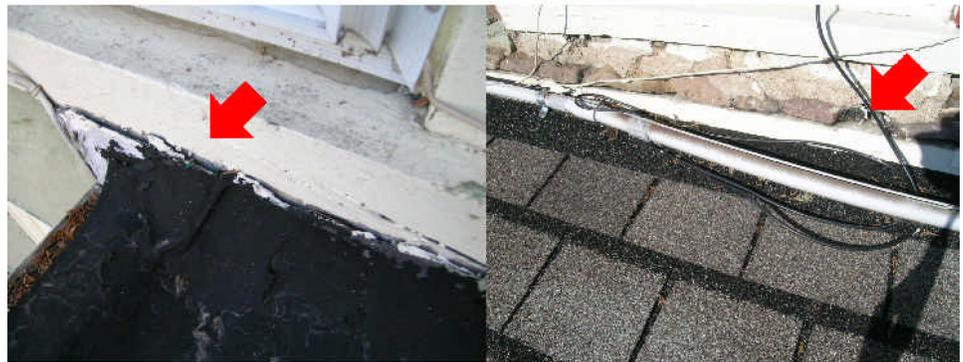
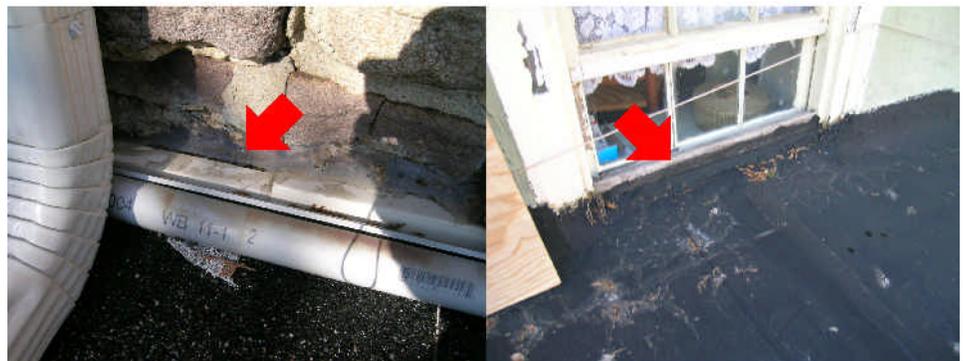
Repair all deteriorated flashing

Proper flashing where roofs abut against old stone farm houses is difficult and costly to install. Even when it is done properly some degree of monitoring and maintenance is necessary.

For this reason somewhat less than good flashing is usually installed at these locations and there is more reliance on tar or roof sealants to prevent leaks. This is the case at several locations in this house. It doesn't take long for the tar / sealant to dry out , shrink, create gaps / cracks, and leak. I did not see / find any evidence of active leakage but I did find gaps and openings where the membrane roofs abut the main house walls and some maintenance is needed where the front porch roof abuts the main house stone wall. Immediate repair / maintenance to all flashing is necessary to prevent either current leakage that is not visible and / or future leaks that will occur. One third floor bedroom window has evidence of water damage likely due from leaking flashing. Buyer also needs to be aware that this house has some unusual flashing conditions that are more likely to leak because of their design , age and installation. Flashing should be checked and maintained yearly with this house. Photos in main report.

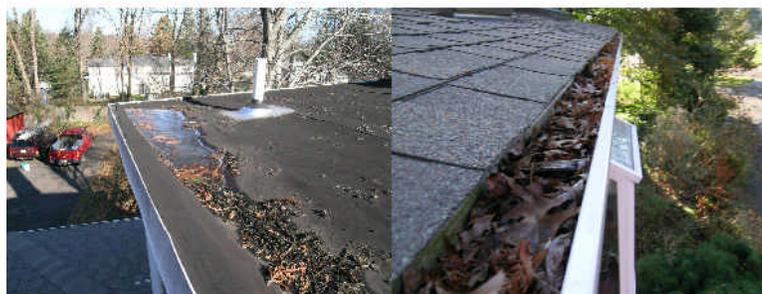
Clean Clogged gutters. !!!

Debris in gutter. Gutters are severely clogged / full of debris and need to be cleaned immediately. Both built in and aluminum gutters. Several down spout extensions are vegetation / vine covered and not visible. Route downspouts away from the building. Recommend installing longer extensions to the ends of the downspouts. This helps direct water further away from the foundation of the house so there is less chance of it going into the basement. Adding an extension of 3 to 5 feet to the end of the downspout elbow can be the difference between several inches of water and a dry basement.

Note: Condition of the gutters is likely at least a contributing factor to the water penetration into the basement.

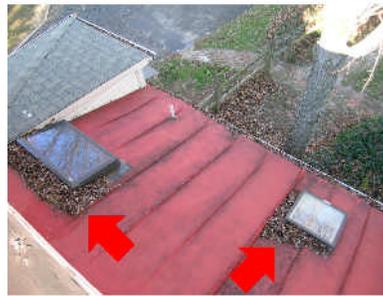
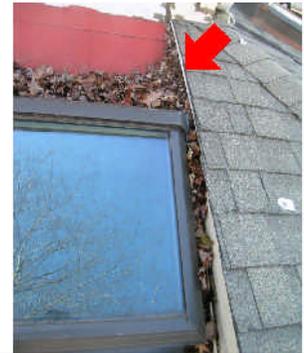
Clean and monitor yearly.

At the time of the inspection there was no evidence of leaks around the skylites. This section is graded marginal because the skylites will need to be monitored. Installation of skylites in old metal roofs is difficult and may rely on caulk / sealant to prevent leaks. Their installation traps leaves and twigs that may prevent water from draining properly leading to leaks. Keep these areas clean and check flashing yearly. Photo in main report.

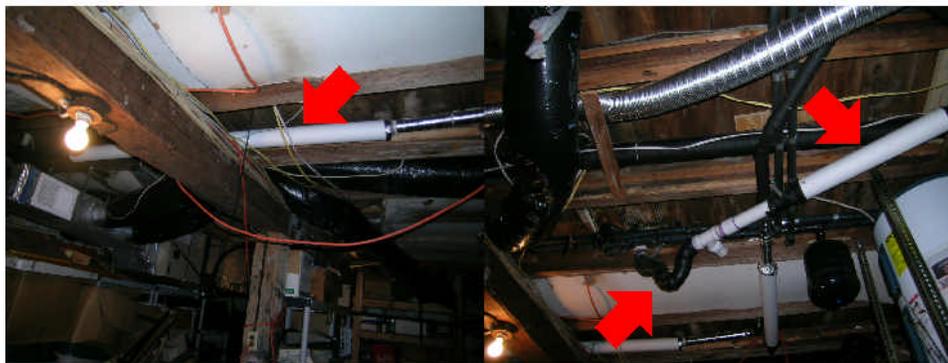
Insulated drains / Improperly sloped

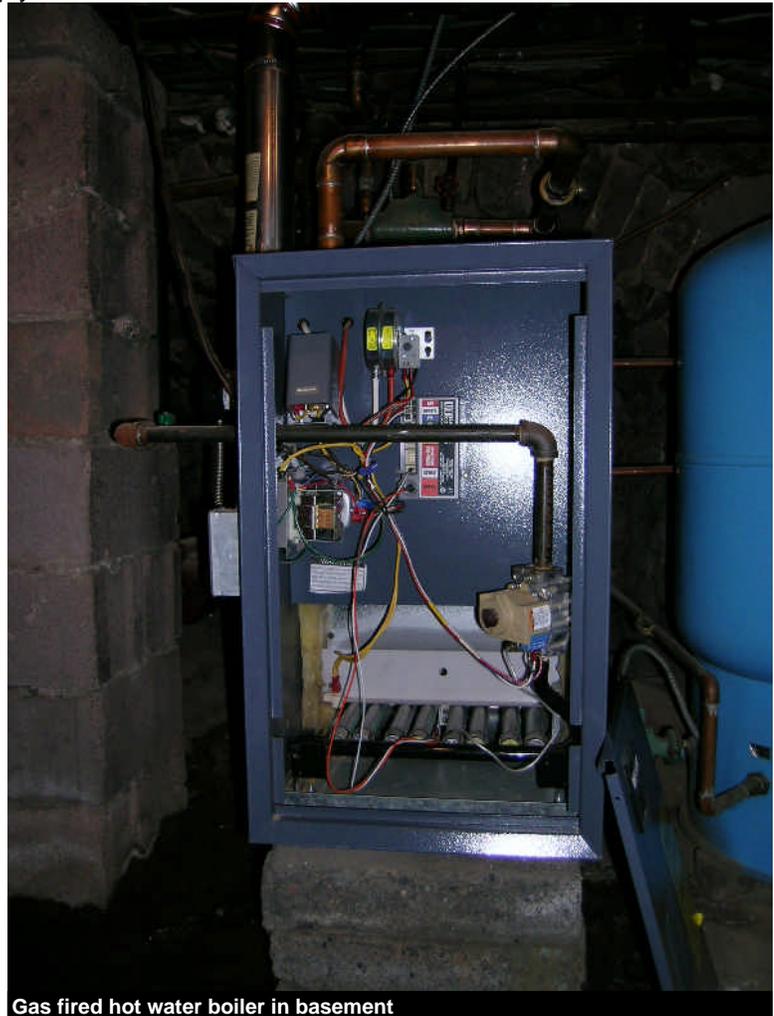
Gas fired hot water boiler in basement

Appears to be in overall satisfactory condition. However this section is graded poor because at the time of the inspection the pressure relief valve severely leaked. I suspect this is just a defective valve but this needs to be confirmed by a qualified technician.

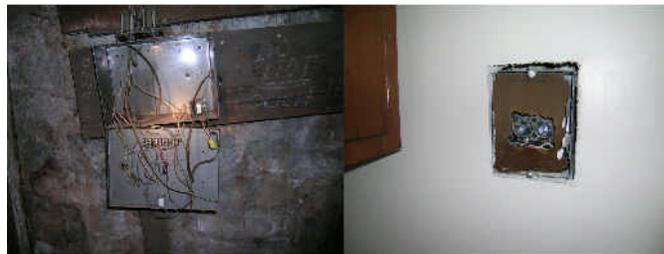
Overall the main panels appear to be in overall satisfactory condition. However, Knockouts are missing at one of the sub panels. A knockout plate is a small metal or plastic plate that covers an unused opening in the panel where breakers may have been removed. If missing, someone could stick their fingers into the panel and be electrocuted. Knock out plates are very inexpensive but they can prevent possible electrocution.

Missing cover plates, exposed hot wires

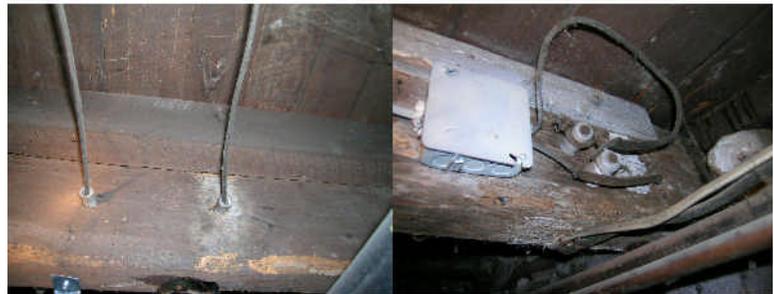
Active knob and tube wiring

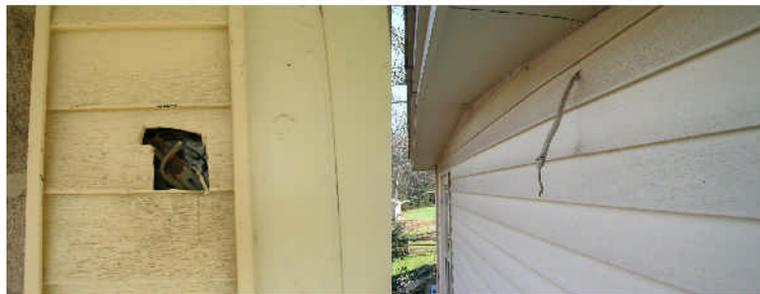
Exposed exterior electrical wires

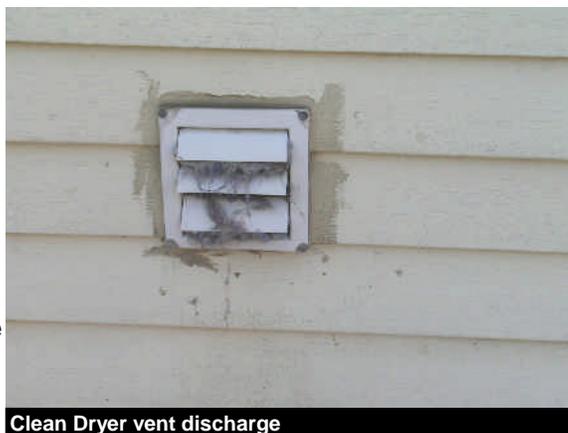
were 15,600 fires associated with clothes dryers in 1998 ,accounting for about 20 deaths, 370 injuries, and more that 75.4 million in property damage. A dryer vent is provided and appears to be in satisfactory condition. Clean dryer vent discharge to prevent possible fire. Photo in main report.

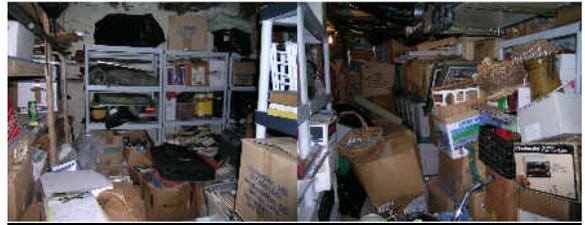
There is a one car garage under the carriage house apartment however it was totally full with storage. View / inspection was very limited. This section is graded poor because further inspection is necessary when all storage is removed. Buyer needs to be aware that there may be wood

Carriage house garage area storage.

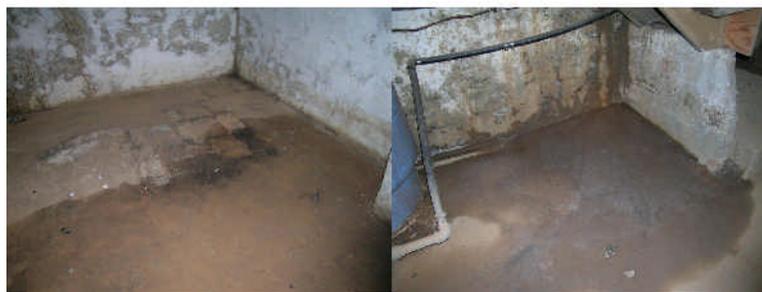
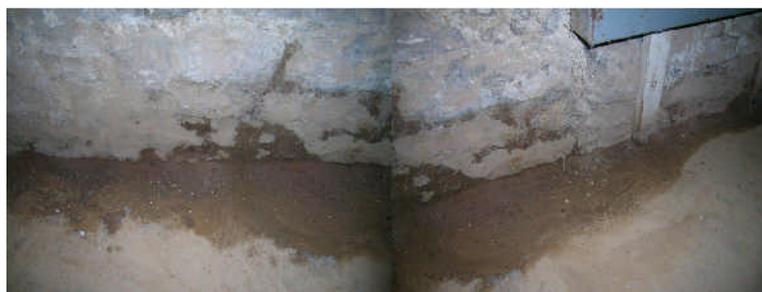
Evidence of water penetration

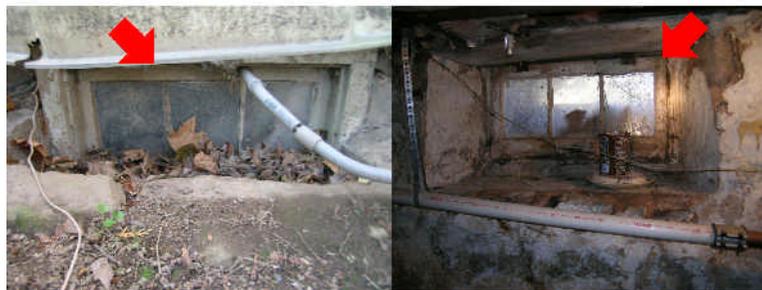
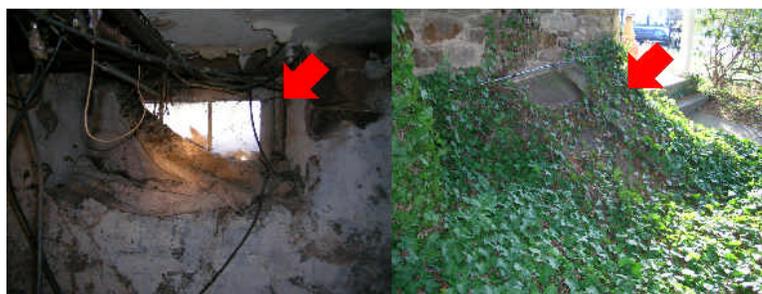
Ivy covered bilco, deteriorated windows

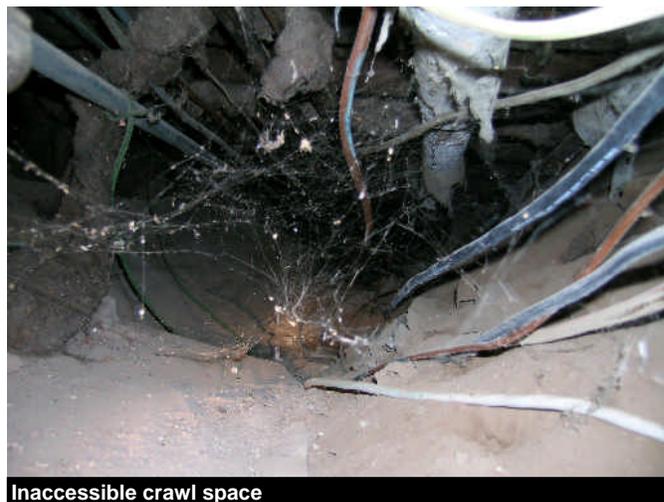
This house has one visible crawl space. There may be others but it could not be determined if they are crawl space or on slab construction. This section is graded poor because buyer needs to be aware that the crawl space or part of the crawl space was not accessible at the time of the inspection, or access was inadequate for proper inspection. Buyer

needs to be acutely aware that crawl spaces are an area where there is a high probability of insect or moisture damage that can not be seen. This / these areas should be accessed and inspected. Now and periodically. Photo in main report.

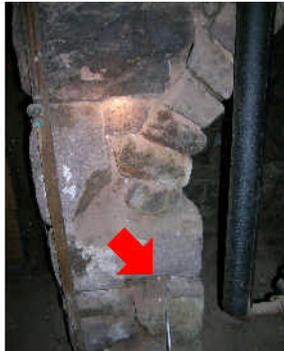
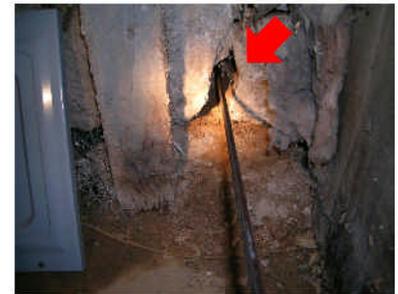
Re-point deteriorated mortar joints

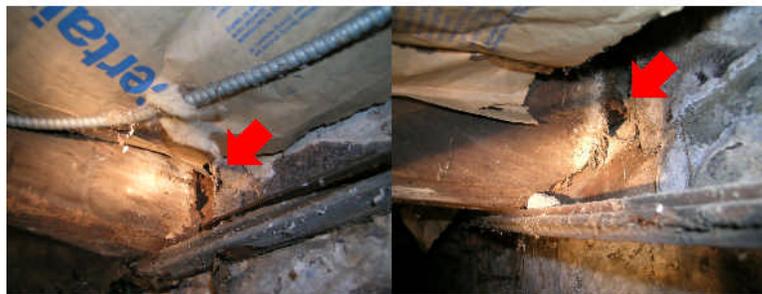
Deteriorated floor joist ends.

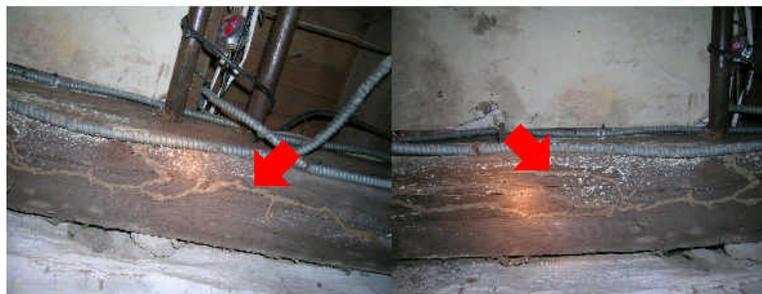
Termite tunnels !!!
