Scott Home Inspections
7398 Tohickon Hill Rd
Point Pleasant Pa. 18950

For: 1600 Pennsylvania Ave NW, Washington, DC 20500

Prepared by: Scott Home Inspections 7398 Tohickon Hill Rd. PO Box 276
Point Pleasant, Pa 18950 215-272-0007 Inspection #1776 Date :Feb. 20, 2000

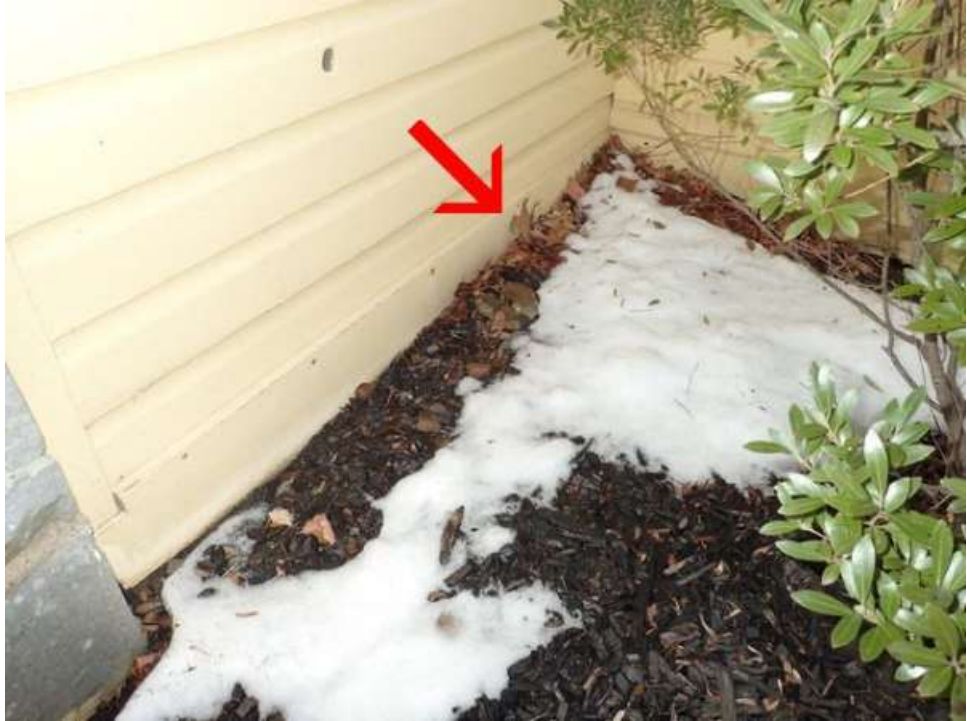
Part or all of the grade around this house would be considered a flat site. Surface water may not drain away as quickly as it should. Water that does not drain away quickly may enter the basement and cause a number of possible problems. Water may not drain away as fast as it should. If water does not drain away from the house there is a higher probability that it will enter the basement.

The soil or mulch should never be in contact / touching the house siding, trim, or wood. Ideally, you should be able to see 6 to 8 inches of your exterior foundation wall. Many times, because of grade restraints this is not possible. But you should never have the soil / grade up to, or over the siding at any time. This condition promotes deterioration from moisture as it transfers to the wood, but even more of a concern is the increased likelihood for insect (including termite) infestation. Many times having this exterior foundation exposure is the best way to prevent insect infestation into the house. Most houses are just not quite high enough out of the ground.

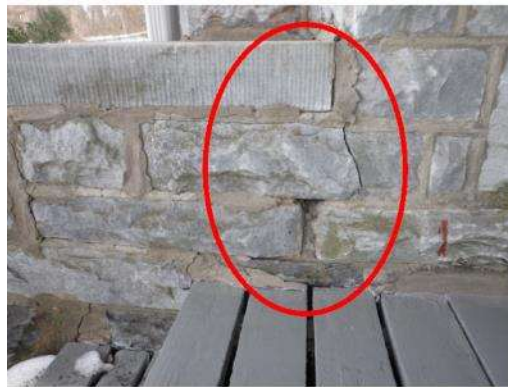
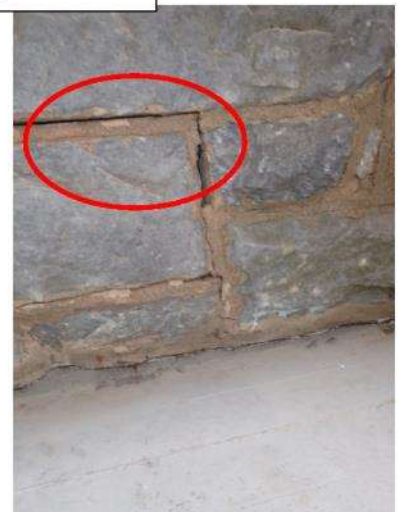
Repair / pointing needed

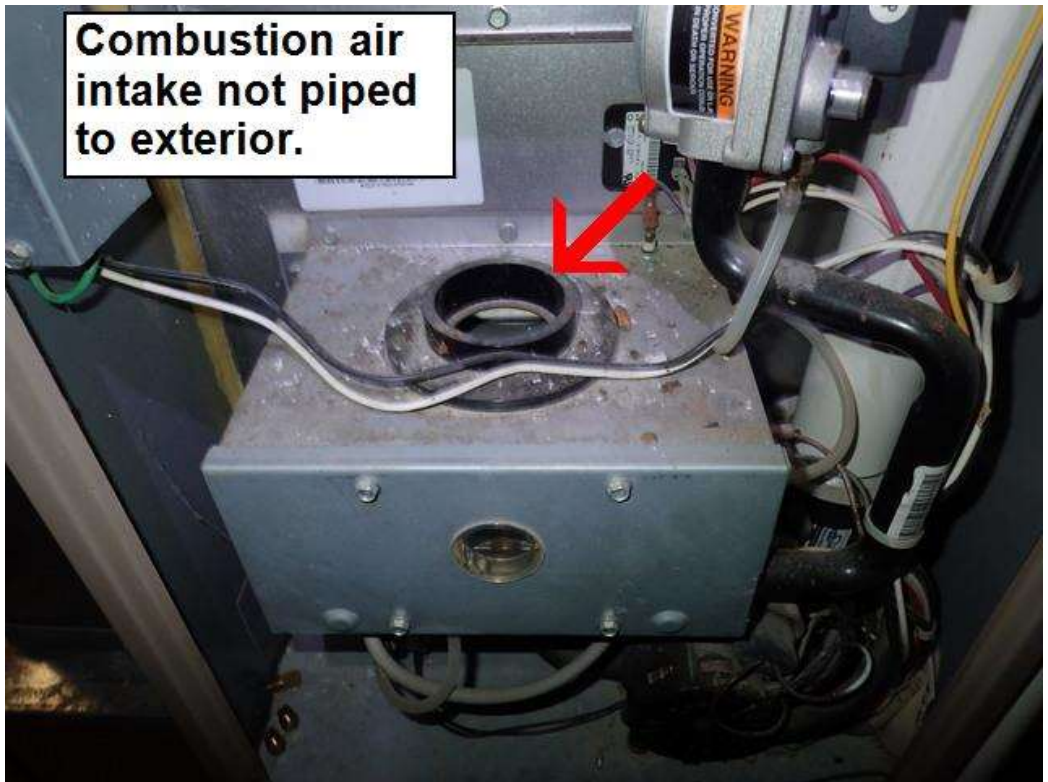
The combustion air intake pipe was not connected. This is not a defect but it does make the furnace less efficient than it could be.

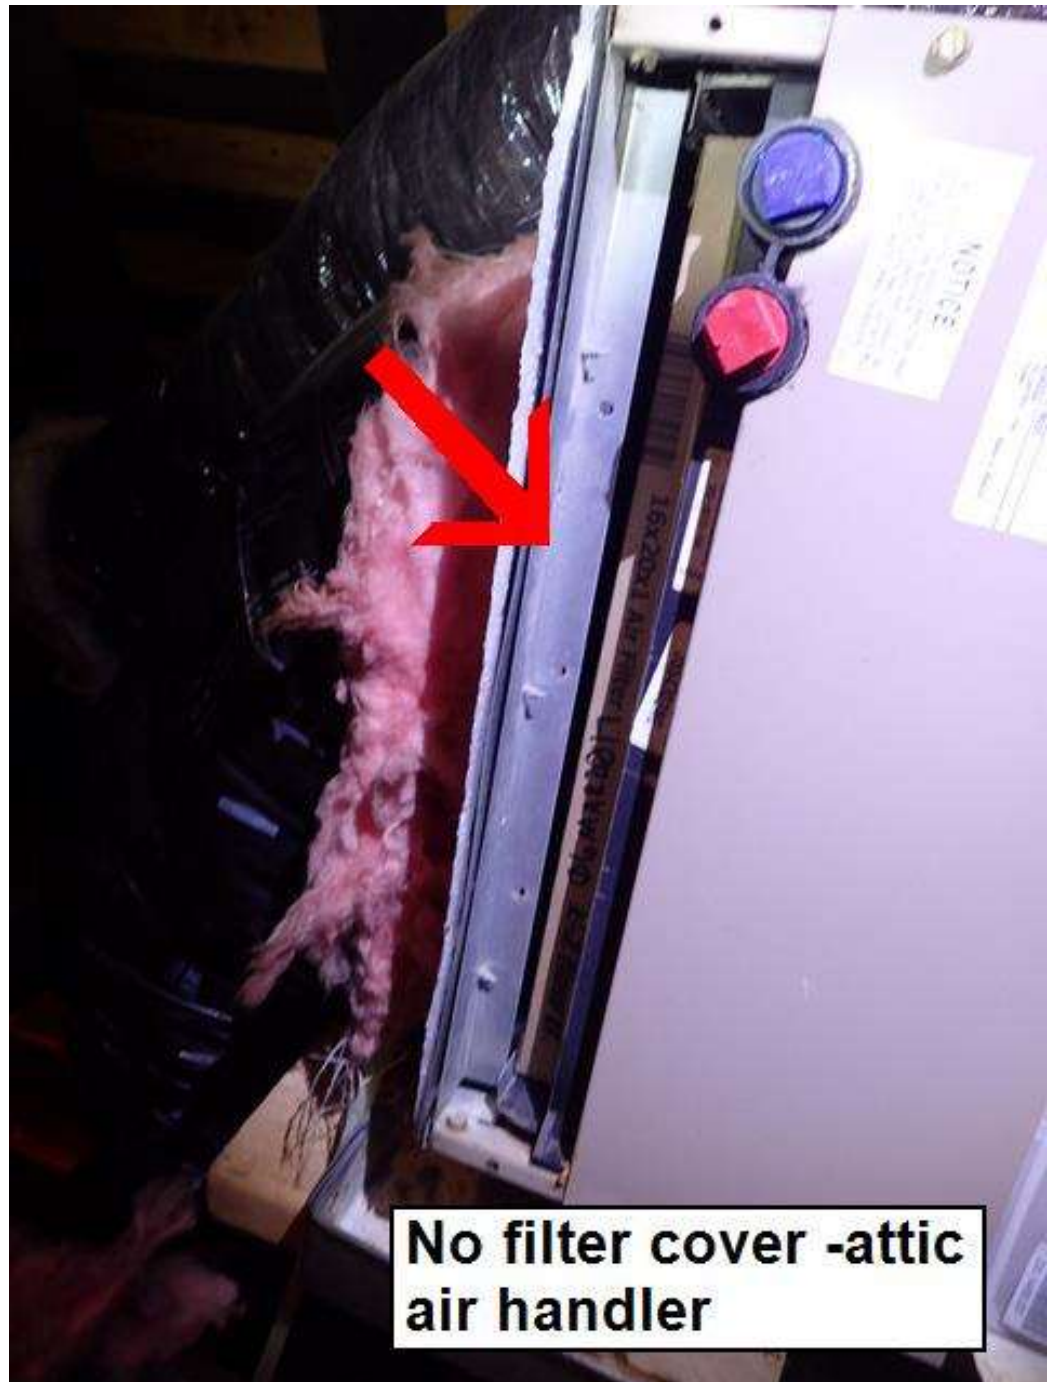
The filter for the central air system is the same as for the heating system. See "Heating System - Air Filter" section.
Several air handlers do not have / do not have adequate filter access cover plates. This enables the system to remove / suck air from the attic and the basement when it should only be removing / sucking air out of the conditioned rooms.

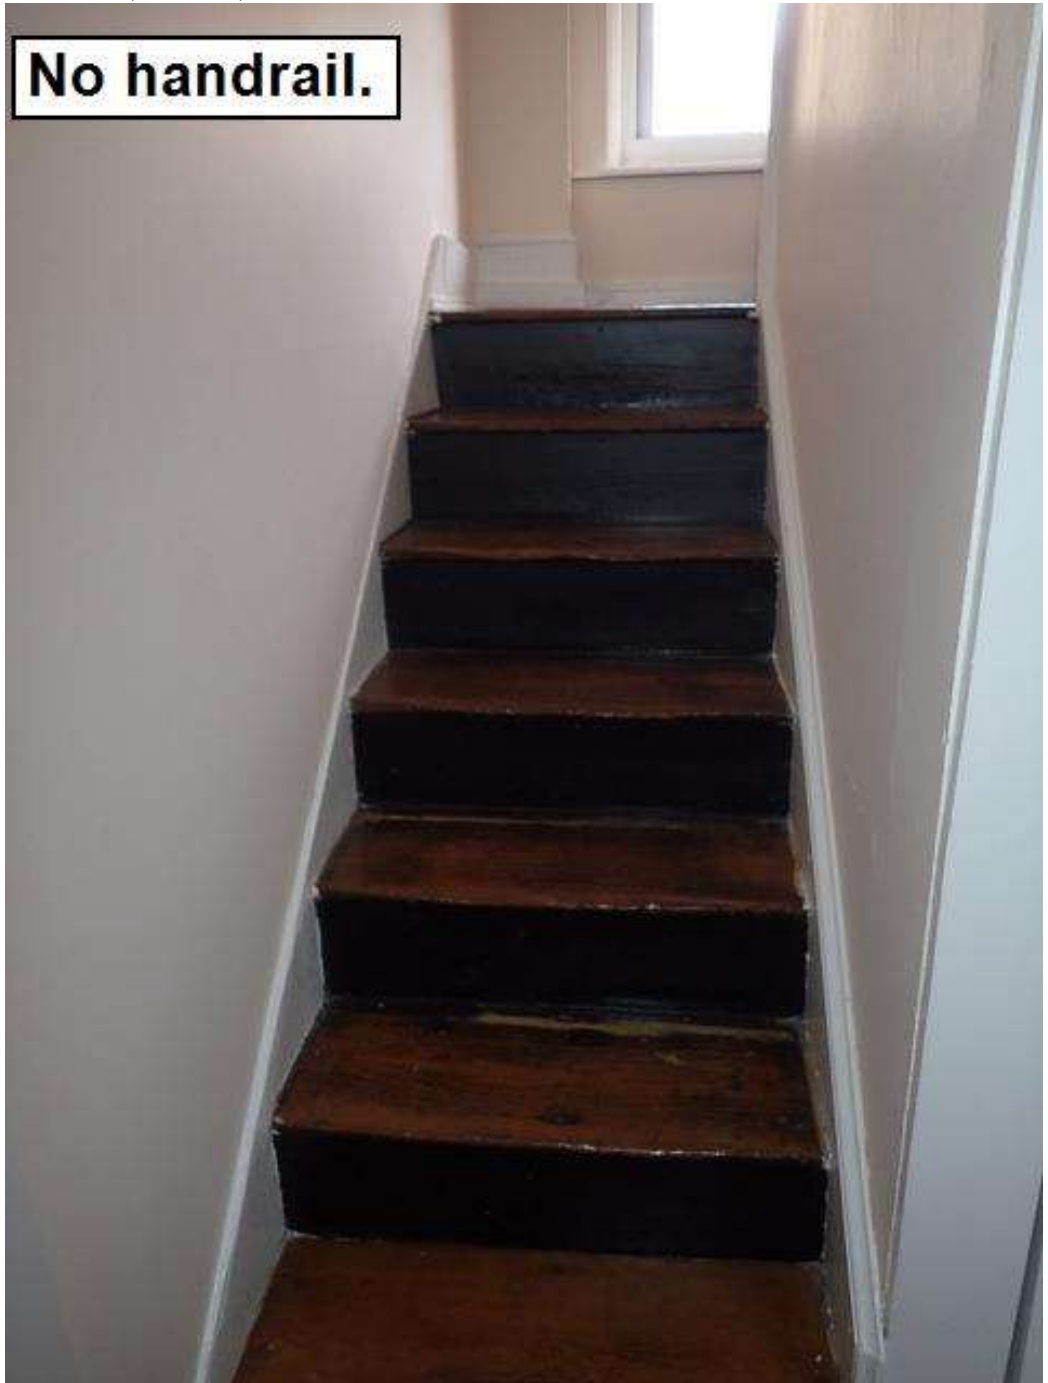
Handrails Missing! Service stairs do not have a handrail. This includes service stairs to basement , second , and third floor.

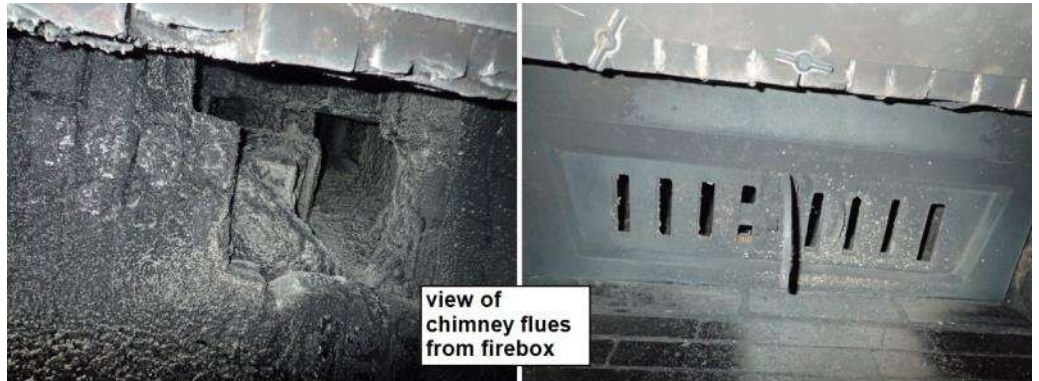
Several fireplaces have been sealed off and are not functional. One has a gas insert and one has been used as a fireplace. I was not able to view up the flues of the two that appeared to be in operation. All are very questionable. Given what was found and the age of this house, along with the potential high cost to repair chimneys like this house has, I grade this section Poor, pending further investigation by a certified chimney sweep. Including a interior camera inspection of the flues and further inspection of the exterior condition.

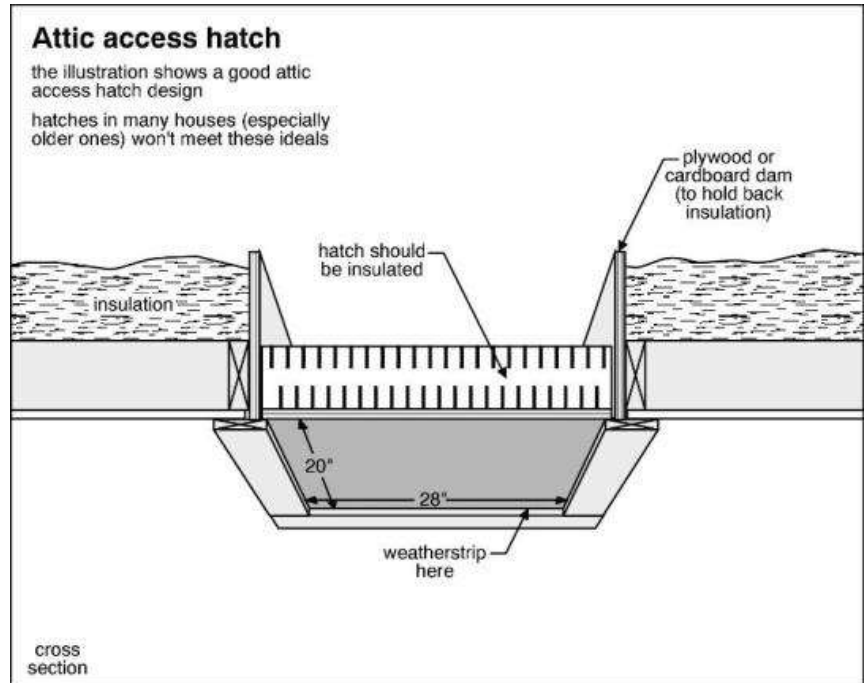
Overall the condition ,of what could be seen, of the attic appears to be satisfactory. This house has an un-insulated attic access panel. An un-insulated attic access panel is like having a opened window in your house all year long. This includes attic or side wall access panels. Diagram shows how shuttle hole access into an attic should be.

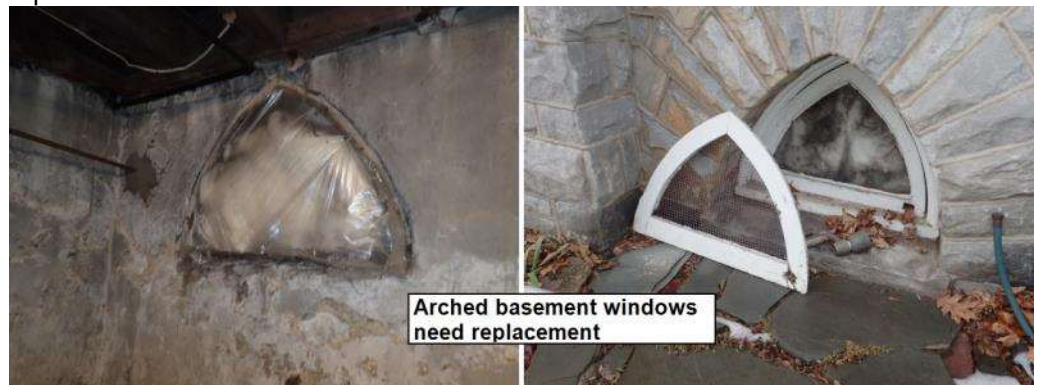
This house has basement windows located at the top / upper portion of the foundation wall. This house has what is generically called a "bilco" style exit door. Several basement windows have been replaced. Several others are at a point where replacement is needed.
