INSPECTION CONDITIONS

REPORT NAME 1994.
FILE #: 0001994.
DATE OF INSPECTION: 12/03/2005.
TIME OF INSPECTION: 8:45 AM -- 3 PM.
CLIENT NAME: Thomas & Khara Flint.
MAILING ADDRESS: 15 E. Butler Ave.
CITY/STATE/ZIP: New Britain PA 18901.
CLIENT HOME PHONE
INSPECTION LOCATION: 25 Scott Dr.
SITE CITY/STATE/ZIP: Churchville PA 18966.

INSPECTED : Old stone farm house with several additions. Detached carriage house with apartment and lower storage. NOT INSPECTED: Several other detached shed / barn type buildings.

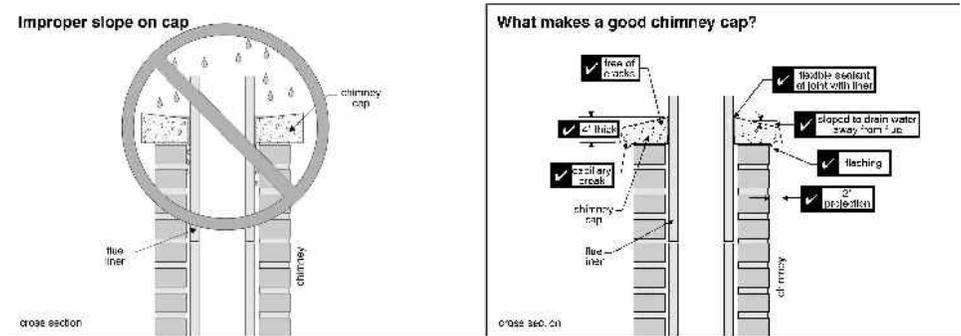
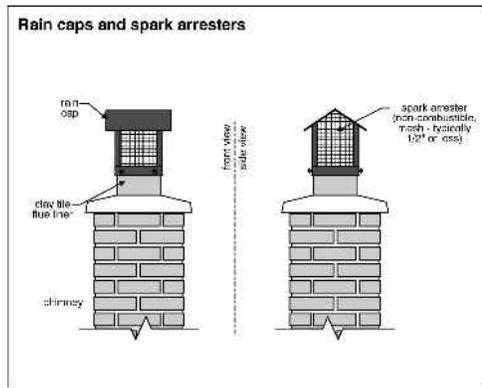
Chimney repair necessary!!!

Repairs needed. The three chimneys appear to be unlined. This house has an unlined flue.

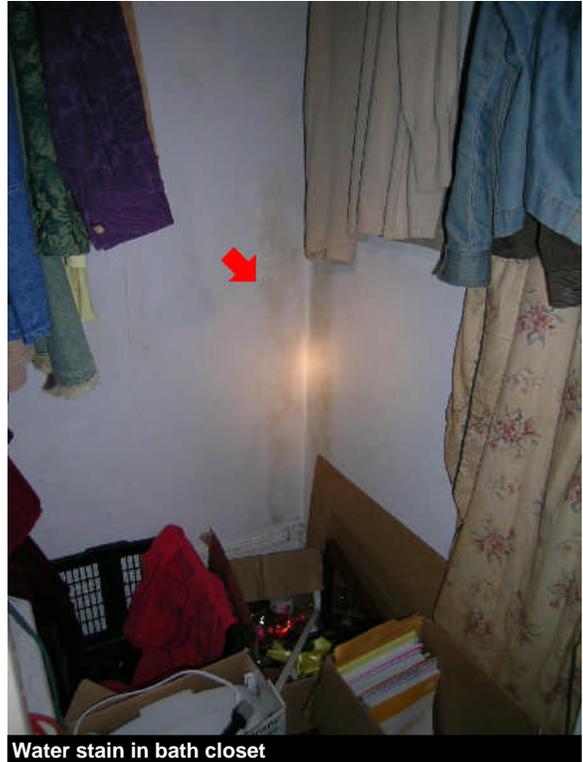
At the time of the inspection I did find evidence of several previous leaks. I found water stains that tested dry with a moisture meter at the time of the inspection. This is an indication that there is not an active / current leak. I suspect they are from before the new asphalt shingles were installed.

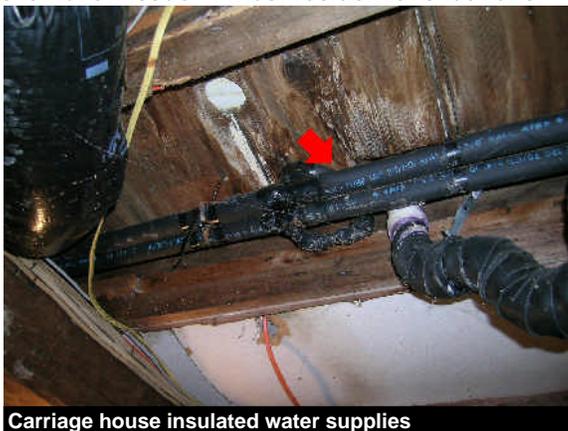
Carriage house insulated water supplies

The domestic water supply pipes that were visible appear to be in satisfactory condition. This section is graded marginal because many water supply pipes under the second floor of the carriage house are exposed and vulnerable to freezing. Insulation installed on most or all of the supply pipes may indicate past problems / freezing. During winter, keep lower barn type doors closed as much as possible and monitor / be aware of the possibility.

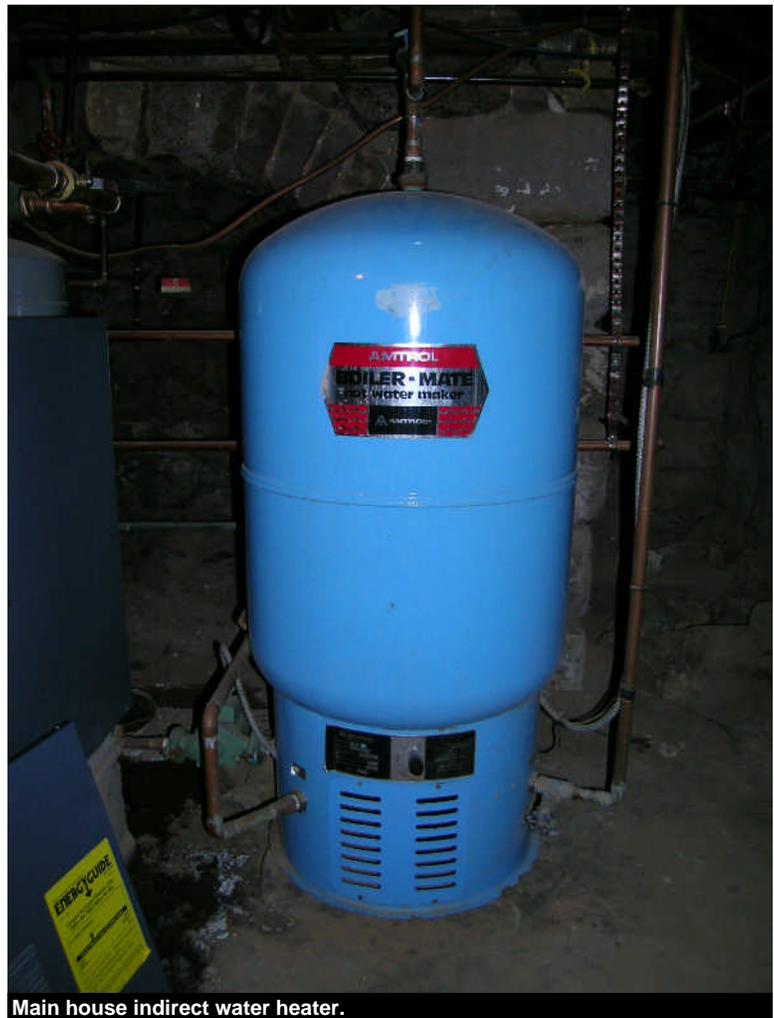
Main house indirect water heater.

The main house has an indirect - fired water heater. There is water in a storage tank that is heated by a coil or copper pipe of very hot water that is supplied by the boiler. (The boiler is the same boiler that supplies hot water to the radiators to heat your house.) This coil / pipe is inside the storage tank. The heat from the very hot coil is transferred to the storage tank water that surrounds it. This is the domestic hot water that you get at the faucet.

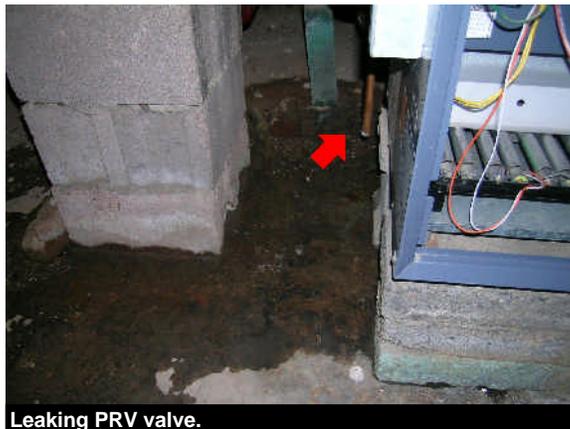
Appears to be in overall satisfactory condition. However this section is graded poor because at the time of the inspection the pressure relief valve severely leaked. I suspect this is just a defective valve but this needs to be confirmed by a qualified technician.

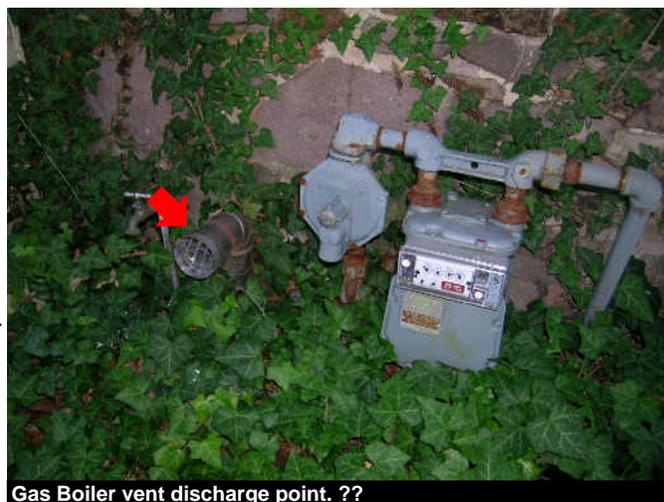
what is called a fan assisted direct vent for the exit of the combustion fumes. It is vented directly to the exterior with plastic pipe, and does not need a chimney. This section is graded poor because it needs to be confirmed that the vent discharge point has proper clearance / distance away from the window above. If it does not combustion gases including possibly deadly carbon monoxide could enter the house. Photo in main report.

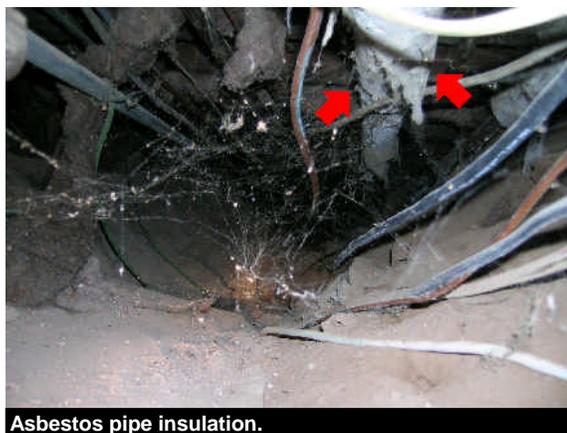
cooling distribution system appear to be in satisfactory condition. However, several radiators did not get hot. Owner stated that he had turned them off. Confirm that they are functional.

I found asbestos insulation wrapped heat pipes in the crawl space. Asbestos fiber in some form, is present in many homes, but it is often not visible or cannot be identified without testing. If there is reason to suspect that asbestos fiber may be present and if it is of particular concern, a sample of the material in question may be removed and examined in a testing laboratory. However, detaching or inspecting for the presence or absence of asbestos is not a part of our inspection.

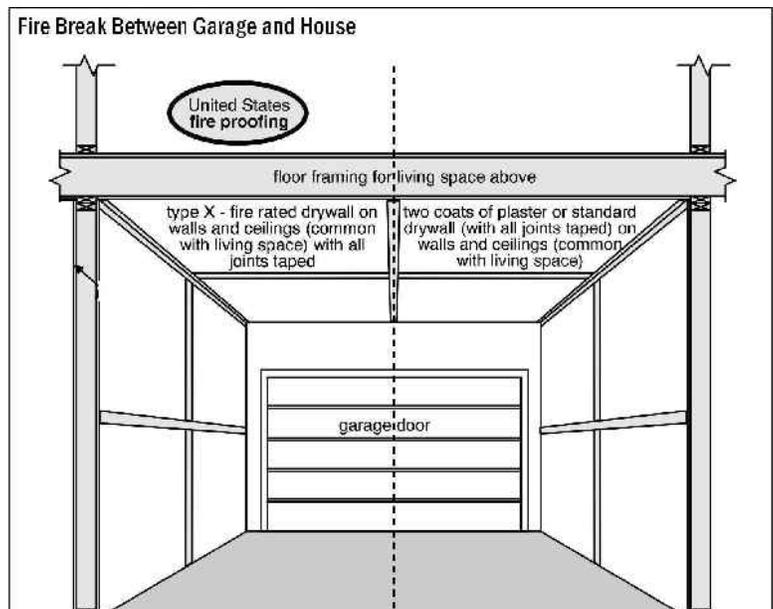
CONDITION: Currently the space under the carriage house is used for storage. This section is graded marginal because buyer needs to be aware that if it is to become a garage for parking an automobile a proper fire wall will need to be installed.

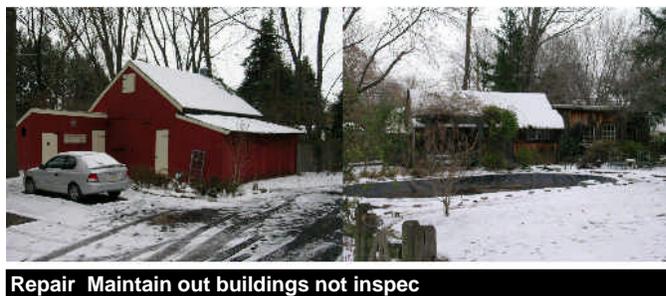
Repair Maintain out buildings not inspec

This section refers to several detached buildings that were not inspected / not included in this general home inspection and therefore this section is graded not inspected. However buyer needs to keep in mind that these buildings will

require some degree of repair and maintenance. This expense needs to be considered in the final decision to purchase. Photo in main report.
