Scott Home Inspections
7398 Tohickon Hill Rd
Point Pleasant Pa. 18950

For: 1600 Pennsylvania Ave NW, Washington, DC 20500

Prepared by: Scott Home Inspections 7398 Tohickon Hill Rd. PO Box 276
Point Pleasant, Pa 18950 215-272-0007 Inspection #1776 Date :Feb. 20, 2000

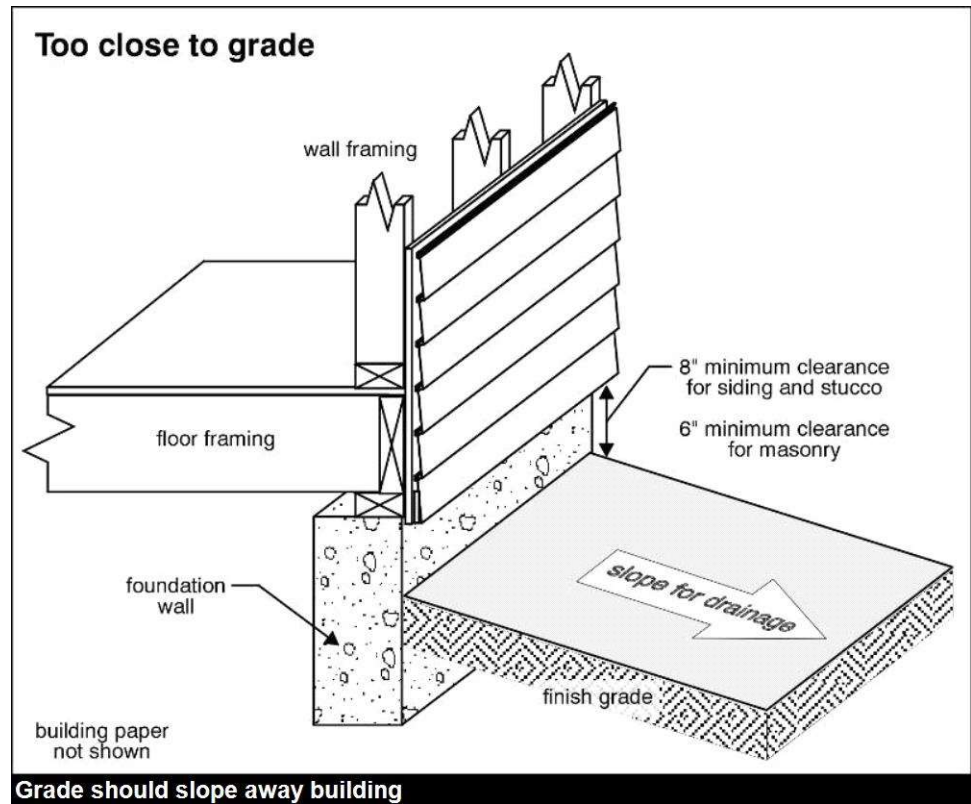
Grade

Part or all of the grade around this house would be considered a flat site. Surface water may not drain away as quickly as it should. Water that does not drain away quickly may enter the basement and cause a number of possible problems. Water may not drain away as fast as it should. If water does not drain away from the house there is a higher probability that it will enter the basement.

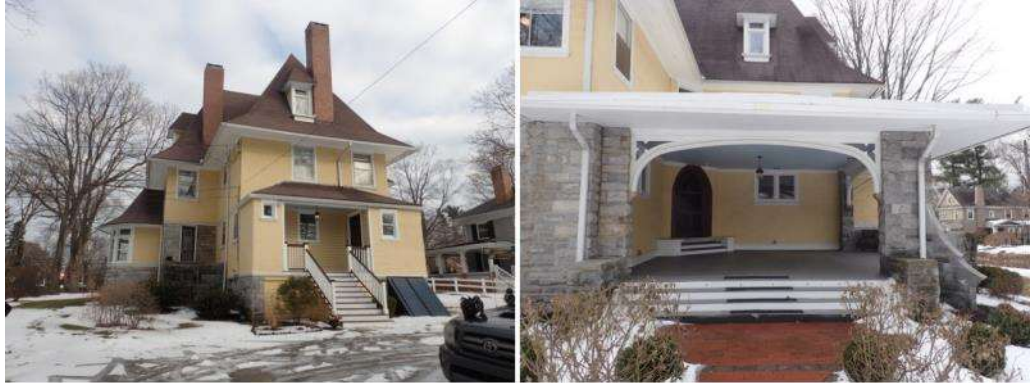
Both porches have wood deck / flooring.

What I found at the time of the inspection would be considered typical to the age of the house and the construction that was used. I saw no reason for concern. No access under front / main entrance porch.

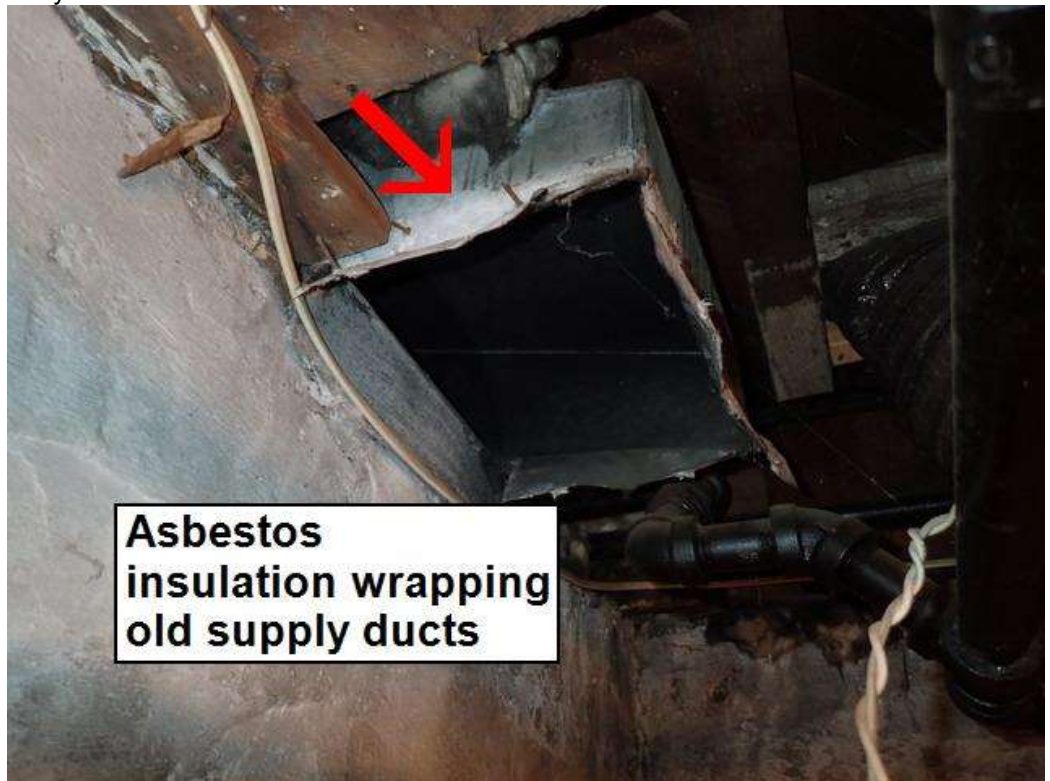
removed and examined in a testing laboratory. However, detaching or inspecting for the presence or absence of asbestos is not a part of our inspection. Buyer needs to be aware that the material that is wrapping the pipes, ducts, or heater likely contains asbestos.

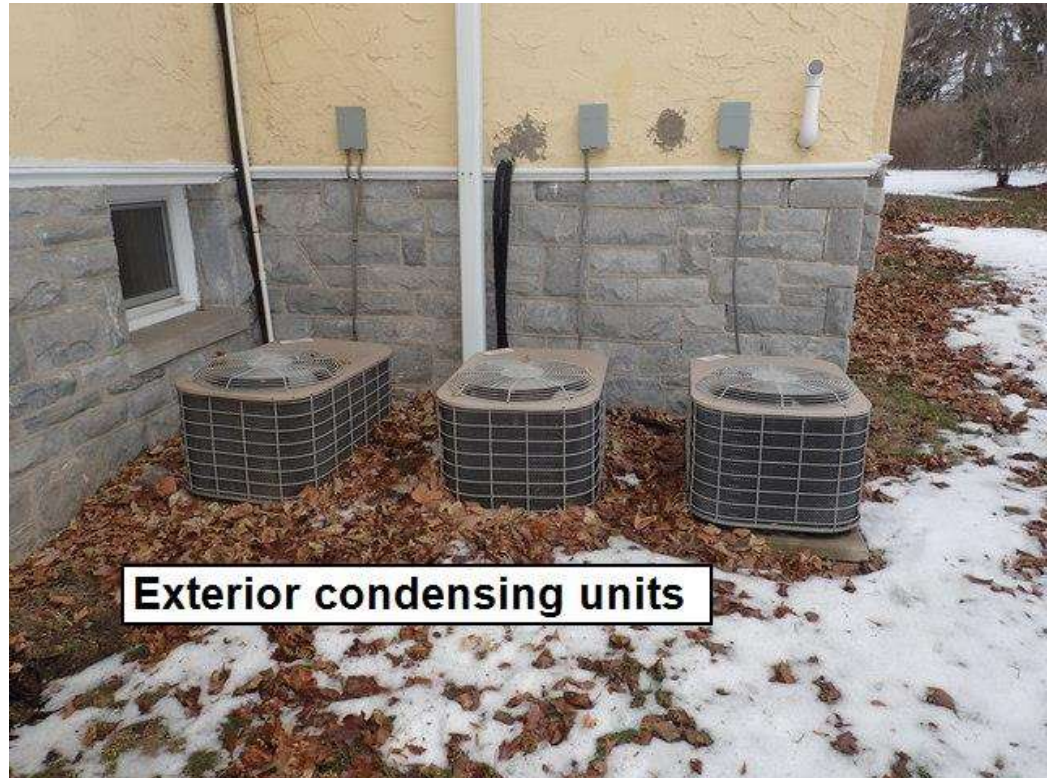
Outside air temperature was below 65 degrees. Unable to test system at this time. Testing central air conditioners when the temperature is too low can damage the unit. Additional concern: The fact that the central air / condensing unit is at the end of it's normal / useful life expectancy, is of additional concern because the system could not be tested at the time of the inspection because the exterior temperature was too low.

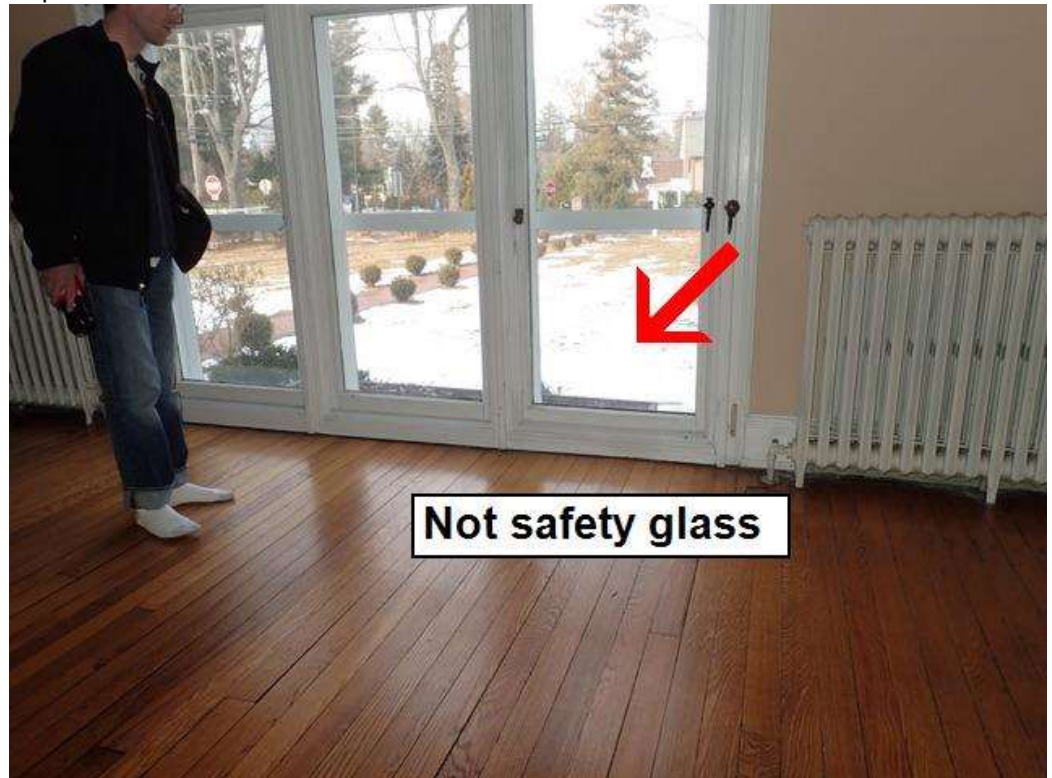
Buyer needs to be aware that there is a high probability of lead paint in this house. This is of particular concern where there are friction points such as window and door jams and lead paint dust can develop.

Some windows are very close to the floor would require safety glass if under current requirements.

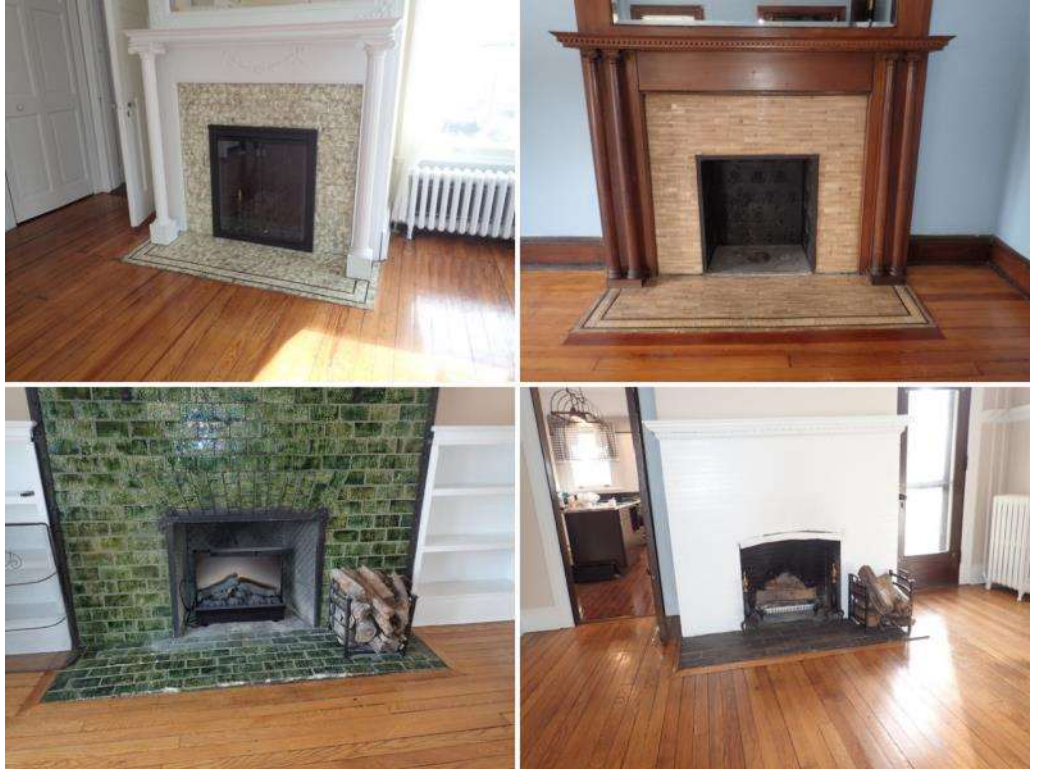
Several fireplaces have been sealed off and are not functional. One has a gas insert and one has been used as a fireplace. I was not able to view up the flues of the two that appeared to be in operation. All are very questionable. Given what was found and the age of this house, along with the potential high cost to repair chimneys like this house has, I grade this section Poor, pending further investigation by a certified chimney sweep. Including a interior camera inspection of the flues and further inspection of the exterior condition.

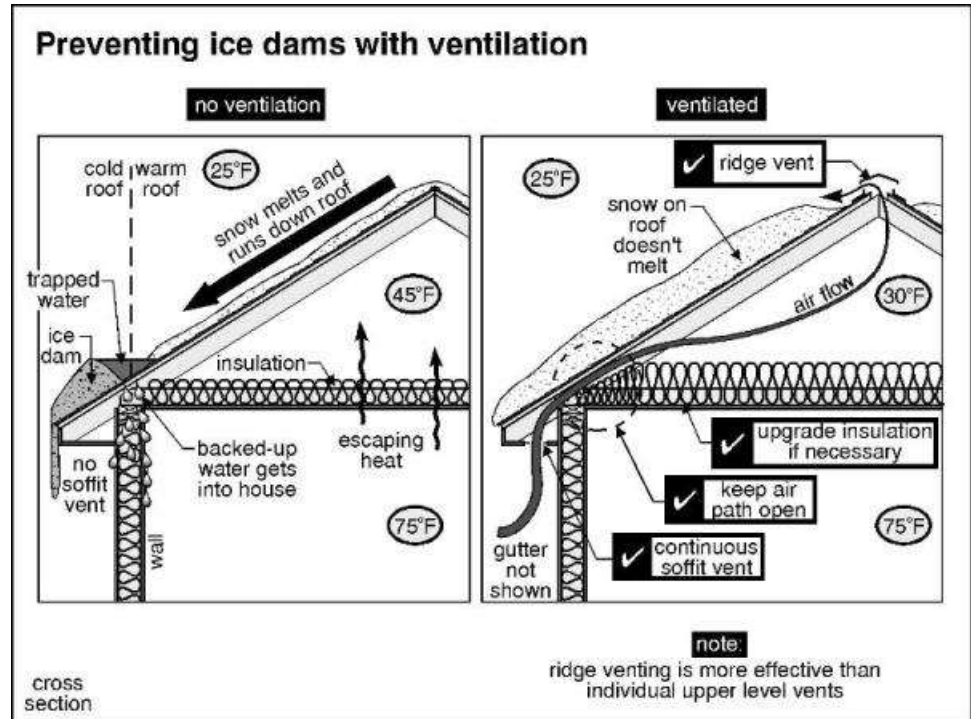
This house / building has soffit vents in at least some areas. an attic fan.

Improve ventilation where / if possible. Consult with your home inspector or contact a qualified insulation / ventilation specialist. Continuous soffit vents (vents under the overhangs / eaves of the roof) in combination with ridge vents (vents that sit on the peak or ridge of the roof) is the best way to completely and naturally ventilate an attic. If you have this system, no other ventilation is necessary. In fact if this system is present installed and functioning properly, any additional or other ventilation systems, such as roof or gable vents, can lessen the overall ventilation and should be sealed off. This system can help prevent ice dams in the winter, lower the temperature in the attic in the summer, and ventilate moisture that may collect in the attic.

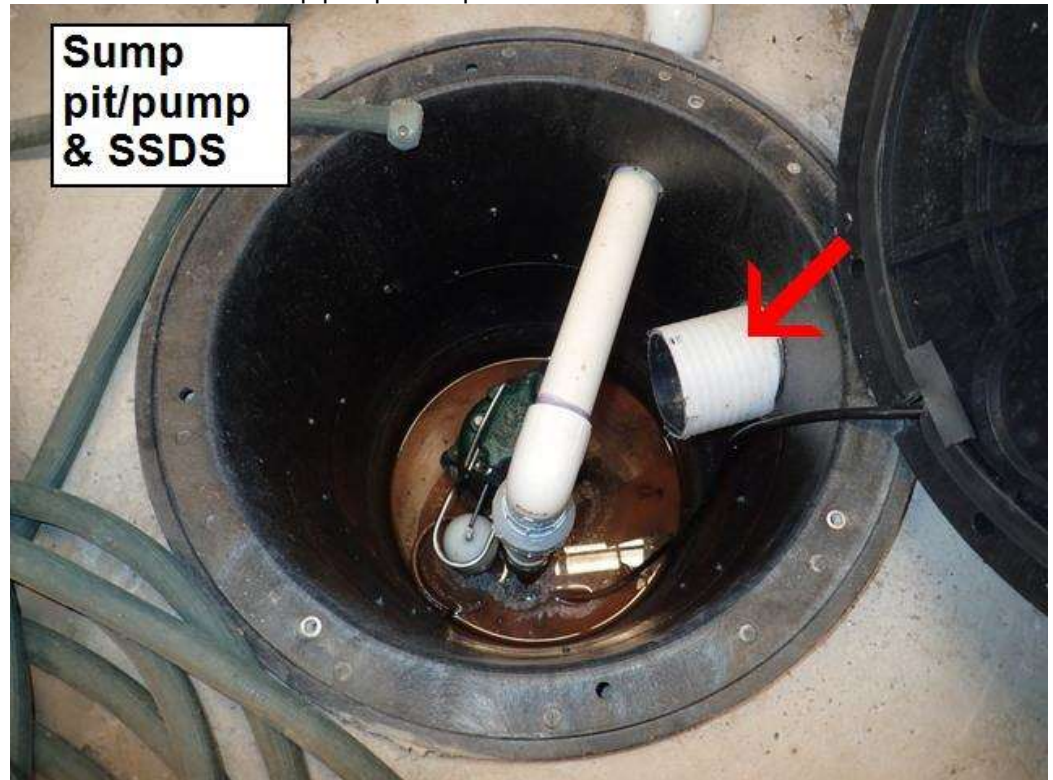
This house has one sump pump that operated when tested.

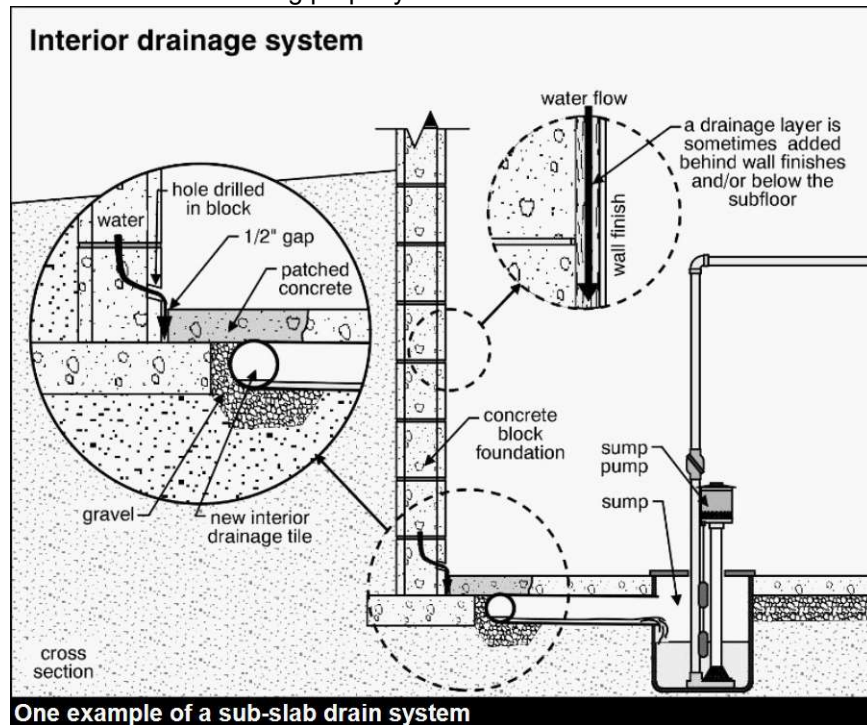
I found evidence of what is called a sub slab drainage system. (Either pre installed or retrofitted) This involves a perforated drain pipe, that has been installed under the concrete floor of the basement or crawl space, that goes either completely or partly around the interior perimeter of the basement. As ground water comes up it takes the path of least resistance and ideally finds its way into this pipe. Once there, the water again takes the path of least resistance which is generally into the sump pump pit where the pump pumps the water out of the basement. If installed properly this is a very good

system. Tapping into this drain system can also make it easier to remediate radon if it is necessary. This system is under the slab and it can not be seen or confirmed that it is installed and / or working properly.
